PHOTOGRAPHIC INTELLIGENCE MEMORANDUM

SOUTHEAST CHINA SITUATION

GP/I-219

2 November 1956

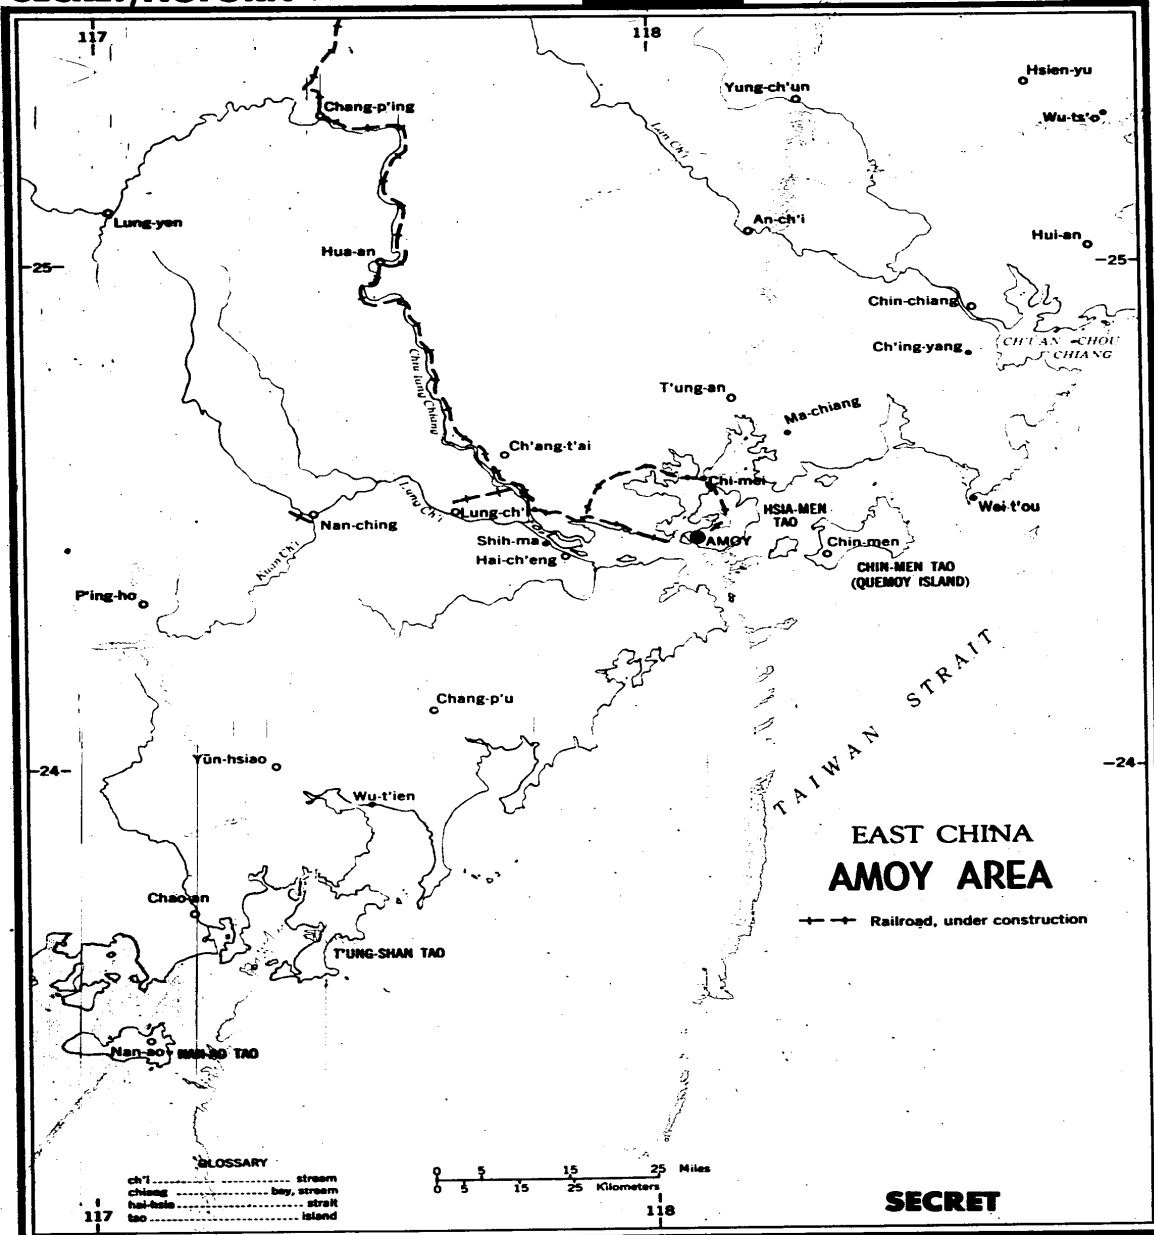
[REDACTED] photography there were indications of railroad construction near the town of Nan-ching located approximately 18 miles west of Lung-chi (See enclosure 2). These indications were drying out of paddy fields, preliminary clearing and construction of an access road along the south bank of the Nan Chi (River). It appears that this work may be a preliminary stage in construction of a railroad from Lung-chi west to Mei-hsien and thence southwest to Canton.

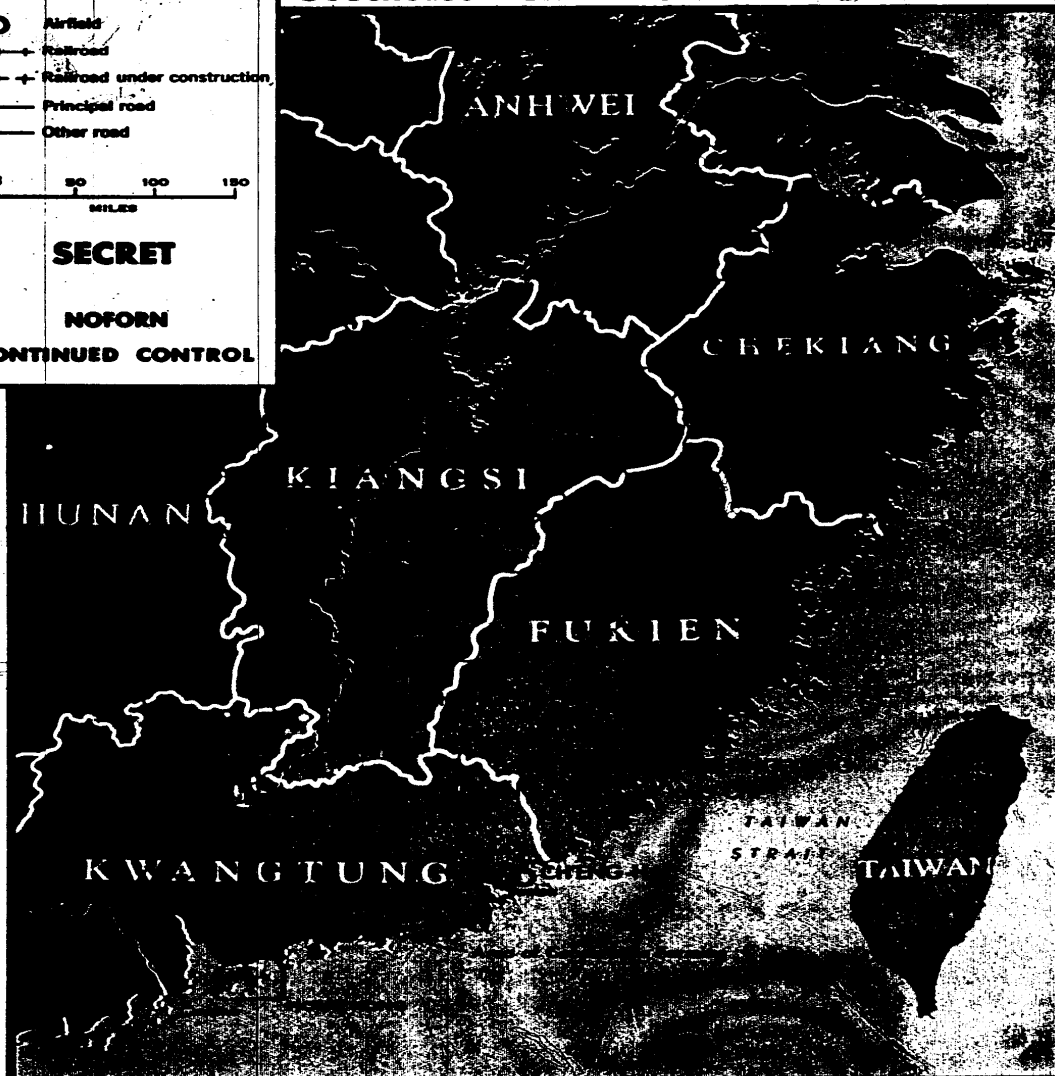
[REDACTED] ferries were still the only means of crossing the rivers at Jui-an and Wenchow on the coastal highway (See enclosure 3).
